YOUR ONESURVEY
HOME REPORT

1 Balgonie Way
Plains
Airdrie
ML6 7EE

SINGLE SURVEY

Single Survey

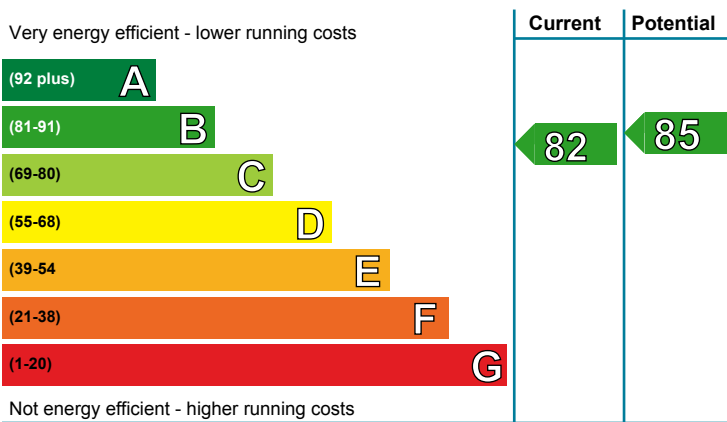
Energy Efficiency Rating

This graph shows the current efficiency of your home, taking into account both energy efficiency and fuel costs. The higher this rating, the lower your fuel bills are likely to be.

Your current rating is **band B (82)**. The average rating for EPCs in Scotland is **band D (61)**.

The potential rating shows the effect of undertaking all of the improvement measures listed within your recommendations report.

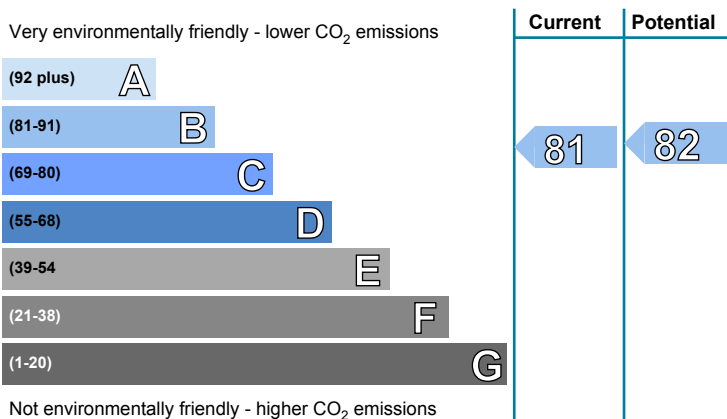
Environmental Impact (CO₂) Rating

This graph shows the effect of your home on the environment in terms of carbon dioxide (CO₂) emissions. The higher the rating, the less impact it has on the environment.
