- 1. Single Survey
- 2. Energy Report
- 3. Property Questionnaire

### Survey report on:

Property Address	22 Lindsay Crescent Largs KA30 9JR
Customer	Mr V Hruby & Mrs G Hruba
Date of Inspection	15/05/2025
Prepared by	Ross Macaulay Harvey Donaldson & Gibson Chartered Surveyors

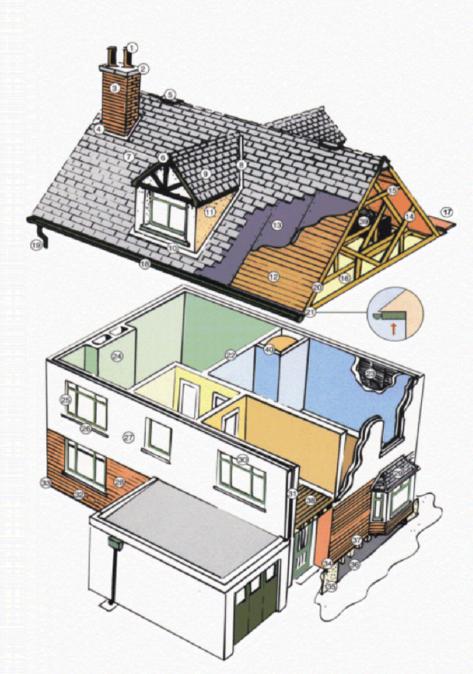
### Sectional Diagram showing elements of a typical house

Reference may be made in this report to some or all of the above component parts of the property. This diagram may assist you in locating and understanding these items. **Chimney** pots 2 Coping stone 3 **Chimney head** Flashing (4) **Ridge ventilation** (5) 6 Ridge board 7) Slates / tiles (8) Valley guttering 9 Dormer projection 10 Dormer flashing **Dormer cheeks** (11) 12 Sarking 13 Roof felt (14) Trusses (15) Collar (16) Insulation 17) Parapet gutter (18) Eaves guttering (19) Rainwater downpipe 20 Verge boards /skews (21) Soffit boards (22) Partition wall 23) Lath / plaster 24) Chimney breast (25) Window pointing (26) Window sills (27) Rendering (28) Brickwork / pointing (29) Bay window projection (30) Lintels 31 Cavity walls / wall ties (32) Subfloor ventilator 33 Damp proof course (34) Base course (35) Foundations (36) Solum 37 Floor joists (38) Floorboards (39) Water tank (40) Hot water tank
