# Home Report

105 John Street  
Larkhall ML9 2EU

# Single Survey

| Property Address | 105 John Street<br>Larkhall<br>ML9 2EU |

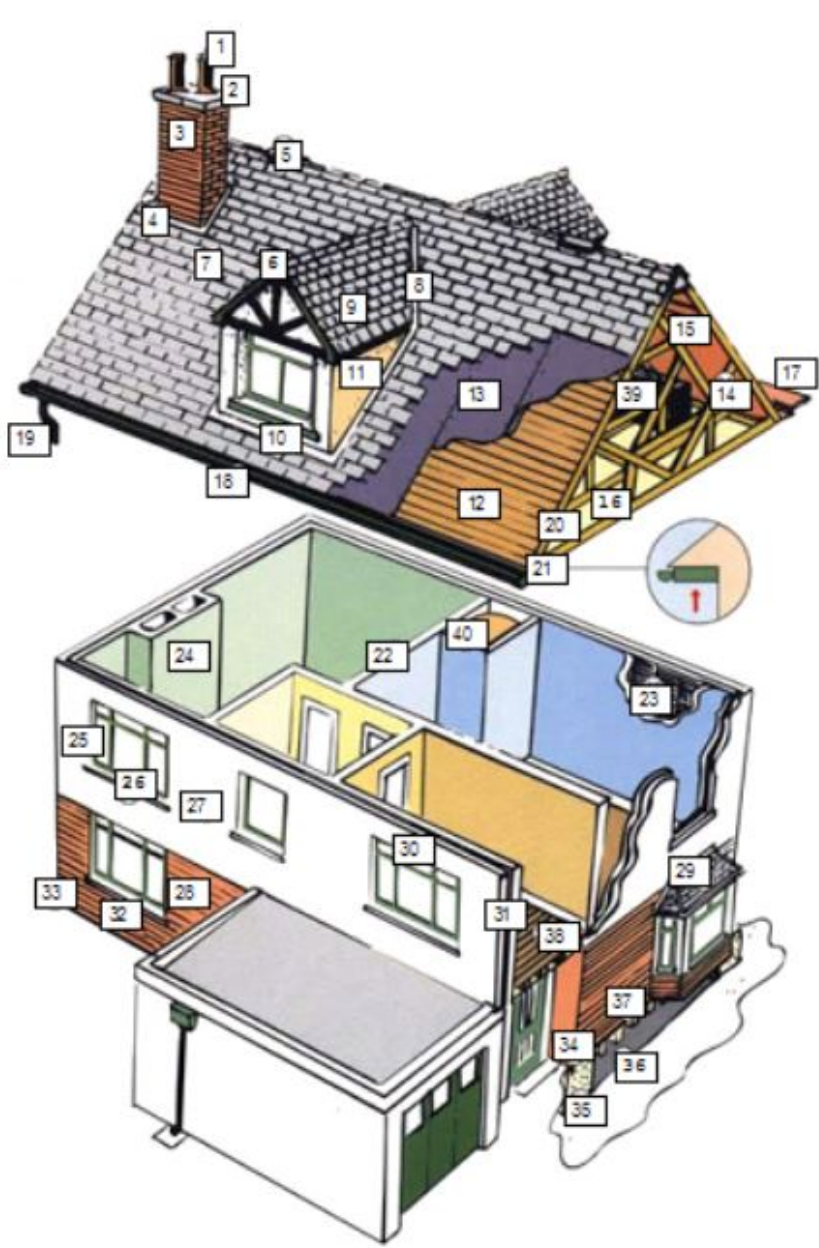
# Sectional diagram showing elements of a typical house

| 1 | Chimney pots |
| 2 | Coping stone |
| 35 | Foundations |
