HARVEY DONALDSON & GIBSON

Survey report on:

Property Address	5 Drumclair Place Airdrie ML6 7AP
Customer	Mr D Stewart
Date of Inspection	28/04/2025
Prepared by	Gosia Kilpatrick Harvey Donaldson & Gibson Chartered Surveyors

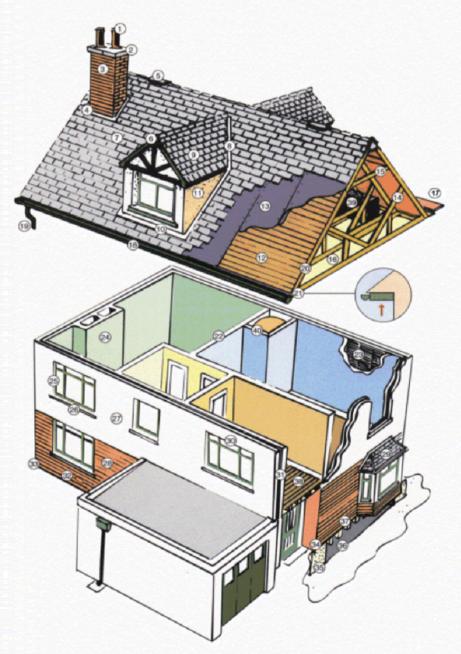
Sectional Diagram showing elements of a typical house

Reference may be made in this report to some or all of the above component parts of the property. This diagram may assist you in locating and understanding these items.

- **Chimney pots**
- Coping stone
- Chimney head
- Flashing
- Ridge ventilation
- 6 Ridge board
- 7 Slates / tiles
- 8 Valley guttering
- 9 Dormer projection
- 10 Dormer flashing
- **Dormer cheeks**
- 12 Sarking
- 13) Roof felt
- (14) Trusses
- (15) Collar
- 16 Insulation
- 17) Parapet gutter
- (18) Eaves guttering
- Rainwater downpipe
- 20 Verge boards /skews
- (21) Soffit boards
- (22) Partition wall
- 23) Lath / plaster
- 24) Chimney breast
- 25) Window pointing
- (26) Window sills
- (27) Rendering
- Brickwork / pointing
- 29 Bay window projection
- (30) Lintels
- 31) Cavity walls / wall ties
- 32) Subfloor ventilator
- 33 Damp proof course
- 34) Base course
- 35) Foundations
- (36) Solum
- 37) Floor joists
- 38) Floorboards
- (39) Water tank
- (40) Hot water tank
